**Ennistymon Tidy Towns**

# POPOSED PROTECTED STRUCTURES FOR ENNISTYMON TOWN.

A SURVEY CARRIED OUT BY BPL TOWN PLANNING Ltd. MARCH 2022 FOR ENNISTYMON TIDY TOWNS GROUP.

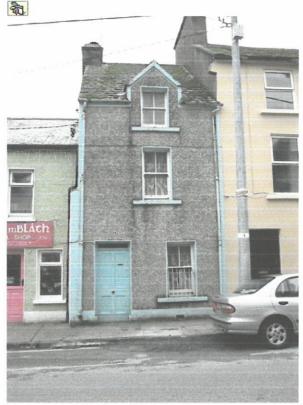
Photograph 1.Setting of Tal slender vernacular dwelling . Parliament Street.

Condition: In good condition and needing conservation.

The roof is of natural slate with rendered chimneystack and rooflight. The walls are constructed of random limestone with a mid 20<sup>th</sup> century pebble dash finish. original windows exist throughout this structure. Interior stairwell of very good quality craftsmanship exists along with many features of original doors and architrave. The roof timber are a combination of hewn and milled large beams.

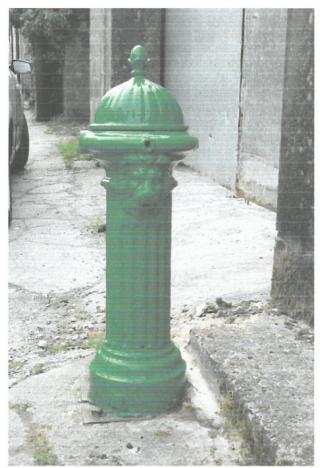
Photograph Setting of Cast iron water fountain Monastery lane Ennistymon

Condition: In good condition throughout restored May 2019

Freestanding cast-iron water hydrant, erected c.1908, comprising fluted shaft on moulded base with lion's head above, surmounted by fluted capping with acorn finial. Inscription 'Glenfield & Kennedy Ltd, Kilmarnock' to shaft. Located along Monastery lane off Church Street in Ennistymon Town.

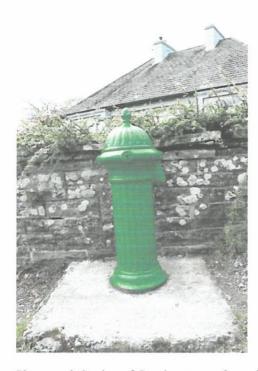
Photograph Setting of Cast iron water fountain, Balgaddy Road, Ennistymon

Condition: In good condition throughout and restored May 2019

Freestanding cast-iron water hydrant, erected c.1908, comprising fluted shaft on moulded base with simple undecorated spout above, surmounted by fluted capping with and acorn finial. Inscription 'Glenfield & Kennedy Ltd, Kilmarnock' to shaft. Located at junction of Balgaddy road and Church Street, in Ennistymon Town.

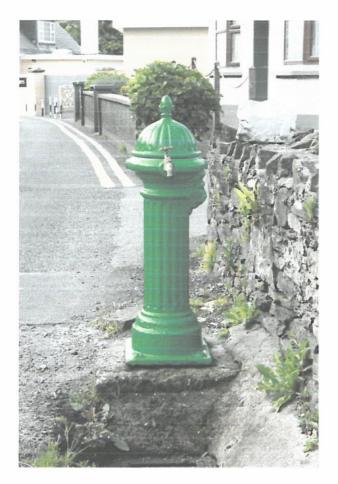
Photograph Setting of Cast iron water fountain, New Road, Ennistymon

Condition: In good condition throughout and restored May 2019

Freestanding cast-iron water hydrant, erected c.1908, comprising fluted shaft on moulded base with a lions head decorative spout above, surmounted by fluted capping with and acorn finial. Inscription 'Glenfield & Kennedy Ltd, Kilmarnock' to shaft. Located at new road carpark adjacent to Nan Aherns old pub.

An attractive cast-iron drinking fountain – water pump which remains an appealing and subtle feature at this junction of the streetscape. This water hydrant is of particular importance as a reminder of the mechanisms installed for the provision of clean drinking water in the period before mains water supply systems and in this case installed by the district council in 1908. The various raised details enhance the artistic design quality of the piece, and indicate the equal importance of aesthetics as well as functionality. The manufacturers of this piece, Glenfield and Kennedy Ltd, were the major company selling cast-iron water mechanisms within the British Empire. its worth asthectically and functionally. It is to be removed as and when the new Ennistymon relief road bridge is built. When this happens this pump could be used in one of the other original site locations of fountains ie Lahinch road or bottom of church hill.

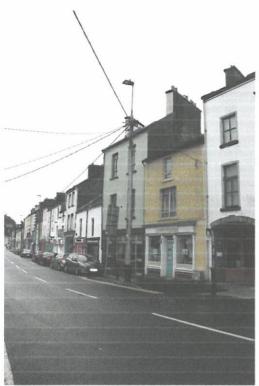
Photograph of Apple Blossom vernacular shopfront newtown main Street Ennistymon.

Condition: In good conditon

**TYPE**: early to Mid 19<sup>th</sup> century vernacular shopfront . Once Aherns bakery and licensed premises.

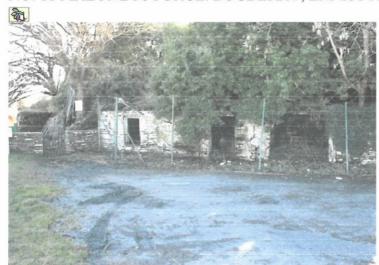
Photograph 1.Setting of Maloney's forge Ennistymon.
As appears in 2022.

Condition: In a poor condition throughout with an intact interior layout and forge chimney canopy where a bellows fanned fire existed. Roof collapsed January 2022.
